Innovative concepts and technologies in the restoration of St Martin church at Meise (B)

Dionys Van Gemert, Triconsult nv, Lummen, en KU Leuven
Gert Heirman, Triconsult nv, Lummen, en UAntwerpen
Dirk Geeroms , Architect, Gent

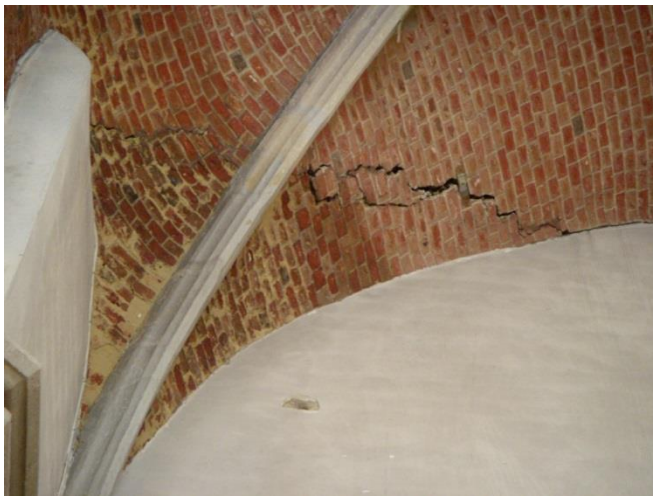
At the end of the 1990's alarming cracks were observed in the vaults and arches, as well as opening of the building seems between the tower and the adjacent chapels, Figures 3 and 9.

Fig. 3 Cracked vault in SW corner of baptistery chapel (2011)

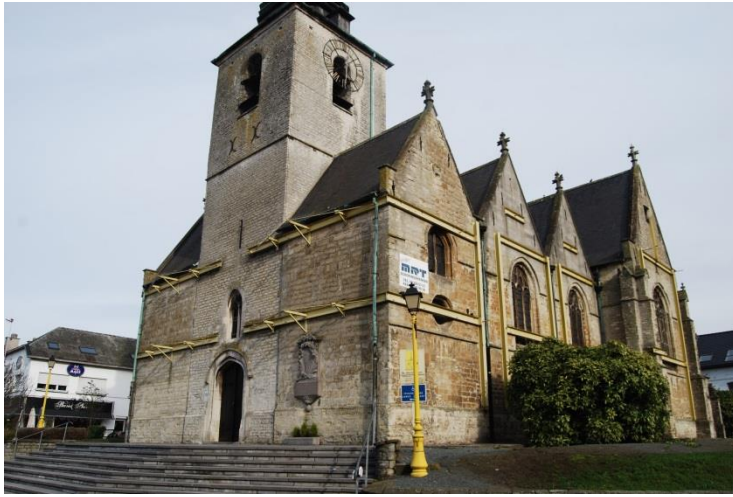
Fig. 4 Stabilizing steel frames for west and south façades (Photograph D. Snauwaert)

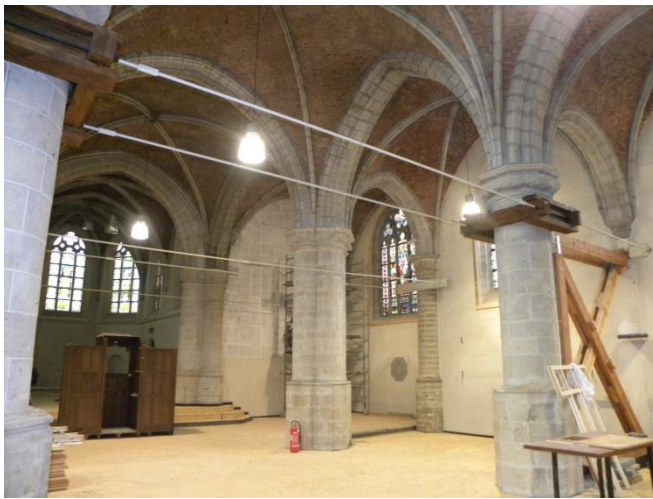
Fig. 5 Double anchors between north and south walls, combined with compression stiff cross shores in the side aisles, and tension stiff connection to the column heads secure the north-south stiffness of the church nave.

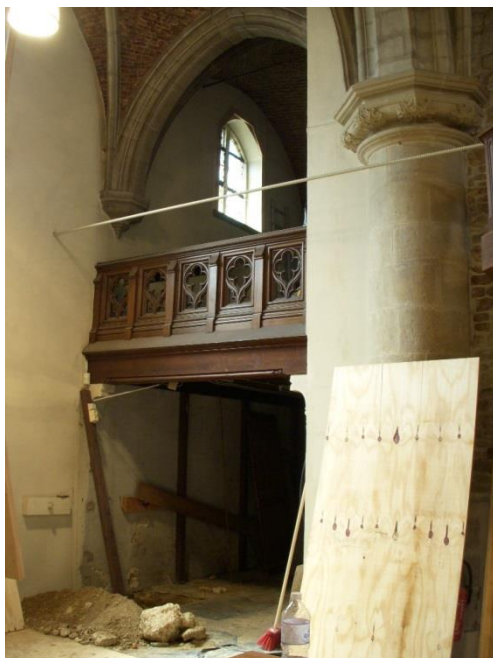
Deformations were also observed at the storage chapel at the south side of the tower. Architect Degand mentioned cracks at the locking stone of the main arch between chapel and first bay of the south side-aisle, as well as cracks in the vaults, Fig. 3. However, no information could be found about an eventual repair of these cracks in the 1949-1950 campaign. Architect Degand also mentioned that the supporting timber beam of the balustrade of the rood loft in the south chapel moved out of the masonry wall over several cm, Fig. 6, 7. All secondary beams of the wooden floor showed an analogous shift. The south wall of the chapel inclined to the south by 80 mm over a height of 6 m, corresponding with the top of the chapel vault. The south wall of the adjacent bay of the south side-aisle inclined by 55 mm over a height of 6.45 m. These inclinations caused the sliding out of the floor beams. These sliding out movements could still be observed at the start of the restoration works in 2011, as well as the solution to this problem provided in the 1949-1950 restoration campaign: extension of the support of the beams by means of a supporting purlin attached to the wall, Fig. 8.

Fig. 6 Balustrade of rood loft in south chapel at tower

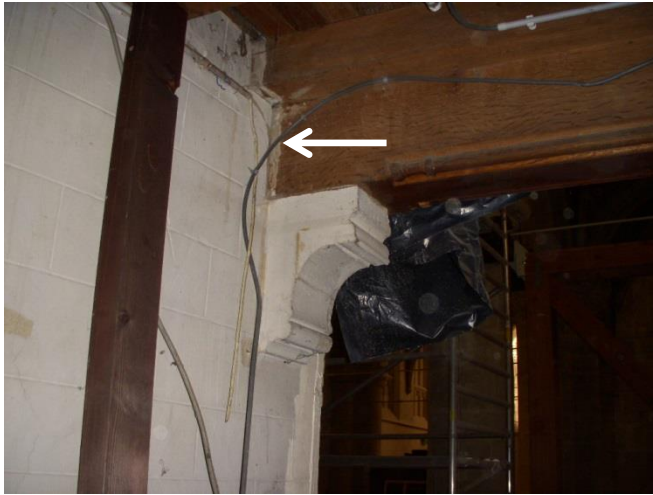
Fig. 7 Supporting timber beam slid out of wall (arrow) (2011)

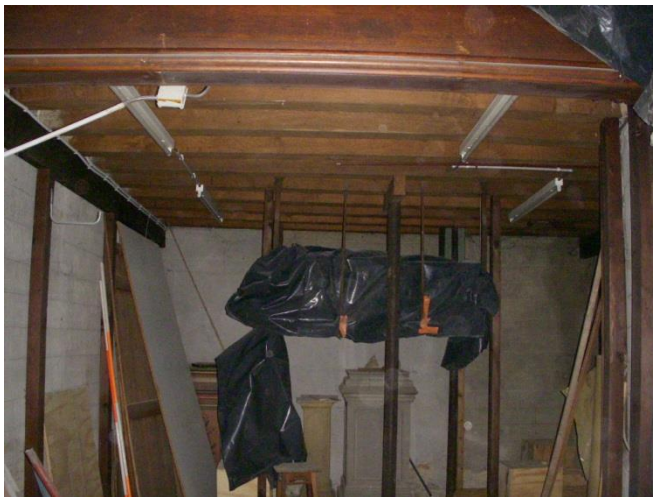
Fig. 8 Left: supporting purlin at straight wall part, serving as extended support for secondary floor beams. Middle: separate steel struts to support the bellows of the organ. (2011)

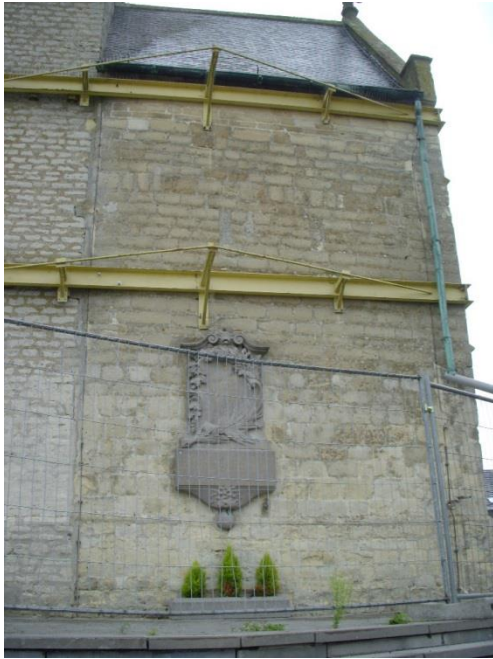
Fig. 9 Open construction joint in west façade between south chapel and tower (2011)

The baptistery chapel at north-west, as well as the storage chapel south-west, are detached from the tower at the building seems. The crack at both chapels is narrow at the bottom, and increasing to the top. As both chapels are additions later in time, that means that settlements of the tower at the moment of the chapel construction had already reached a nearly final stage. The chapel walls further away from the tower will settle more, whereas the parts against the tower do not settle anymore. The global movement of the chapel will thus become a tilting away from the tower, as observed. The tilting is smaller for the north chapel, and larger for the south chapel. However, in the north chapel an out of plane movement happened at the building seem with the tower, caused by the vault pressures from the brick masonry vaults in the chapel. Crack openings at the top are still limited to about 10 mm, which means a differential settlement of about 5 mm between the corner of the chapels and the tower. The chapels are shown in Fig. 4 and Fig. 9.

The crack in the west wall of the tower is strengthened with bored in, grouted anchors according to the scheme in Fig. 30. The cracked and shifted building seems between the tower and both chapels are strengthened or 'stitched' in the same way.

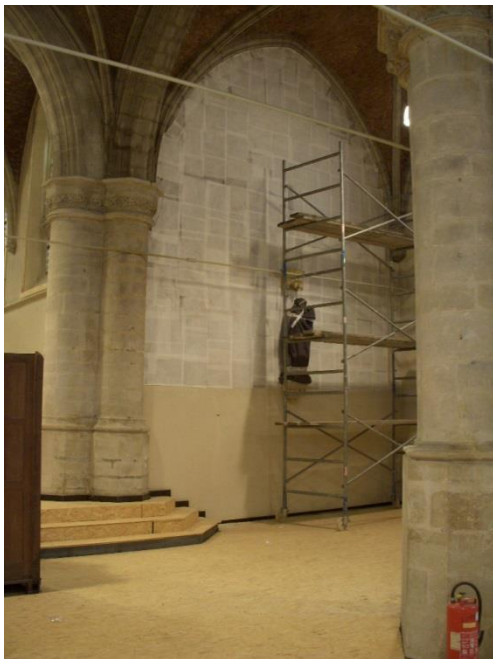
Our investigations in 2011 revealed that the west wall of the chapels also showed a lateral displacement to the west. The observed crack patterns and incline of walls indicate that the building suffered from foundation differential settlements. But some of the deformations and inclines had already been integrated and stabilized in a successive construction or renovation phase, e.g. the incline of the south-east crossing column, Fig. 10. The incline of this column is about 2 cm per m height. However, the transept wall perfectly fits to the column, without any fissure in the wall plane. That is only possible when the wall is built afterwards against the column. The same holds for the north-east column.

Fig. 10 South-east crossing column, corner between choir and transept, with strong incline. Wall painting covered with Japanese paper, for protection during restoration works.

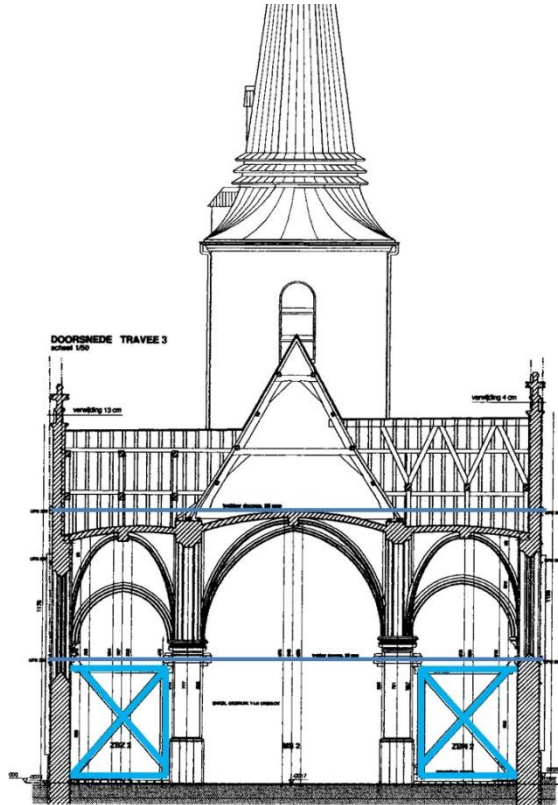
Fig. 11 Tension rods for the free standing columns: one at level of column heads; one above the vaults

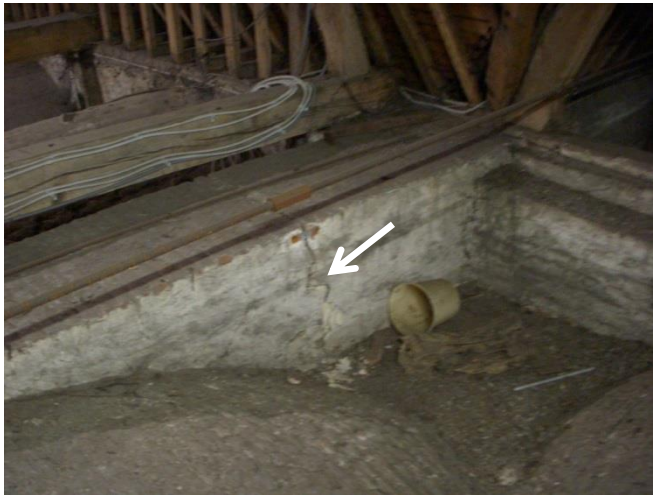
The settlements of the transept ails had caused a large crack in the dividing wall between nave and choir, Fig. 14.

Fig. 14 Crack in dividing wall between transept and choir. Crack opening about 25 mm.

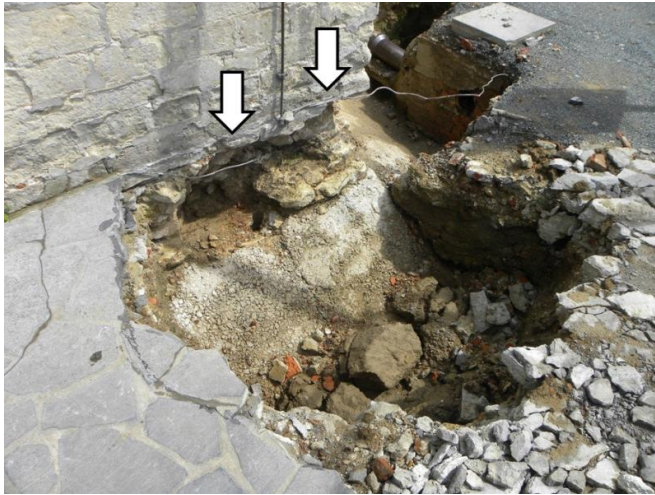
It was observed that the foundation masonry just above the footing was strongly eroded, as shown in Fig. 17.

Fig. 17 Pit 1 Concrete footing. Erosion of masonry just above reinforced concrete footing, SW corner, pit 1 (zone under arrows)

To obtain a perfect, stiff and stable connection between the foundation masonry and the reinforced concrete footing under the south wall, the masonry was consolidated by means of an injection with mineral grout. The less coherent foundation masonry of the west wall of the baptistery chapel was injected as well. The used injection grout is a ternary lime-cement-pozzolan grout. Its composition is as follows, per 100 kg binder powder:

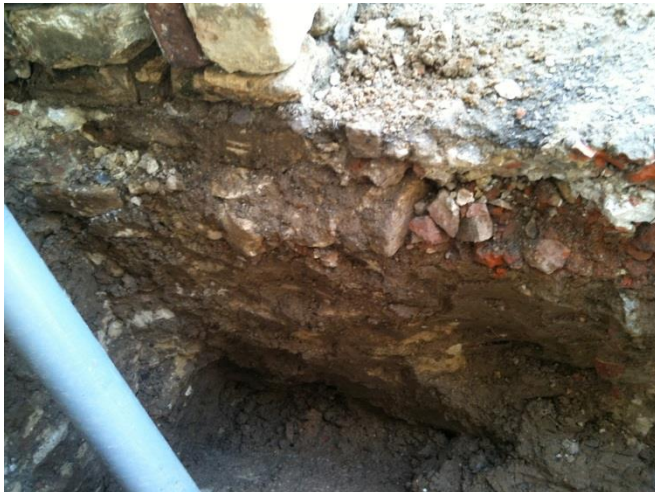
Pit 3 next to the transept wall and the SW buttress of the transept is shown in Fig. 18. Here, the foundation masonry under the buttress is in good condition, with good cohesion. The onset of the transept foundation is at 1.9 à 2.0 m under ground level. The concrete footing projects 1.13 m out of the wall plane.

Fig. 18 Pit 3: foundation masonry of transept wall (left) and of SW buttress (right)

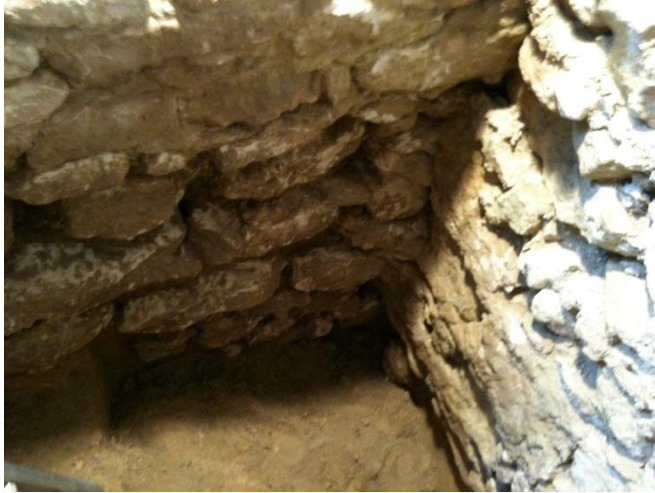
Fig. 19 Pit 4, inside of the tower foundation masonry, viewing direction NW

Fig. 19 clearly shows that in the bottom masonry the stone blocks are placed without laying mortar. Only the upper part is built with mortar. The onset is at 1.73 m under the pavement level in the tower. In pit 5 it could be observed that the front façade of the church projects about 20 cm out of the foundation masonry. However, with wall thicknesses of 1.1 m in the foundations, and 1.0 m in the tower shaft, such eccentricity hardly influences the vertical load and stress distribution.

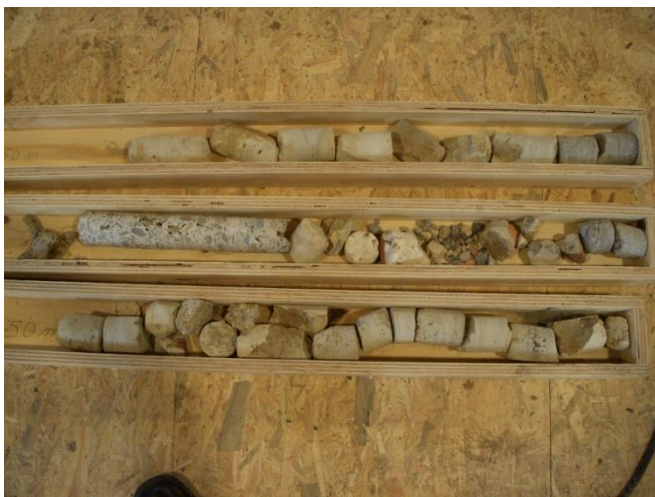
Fig. 20 Cored cylinders B1 (bottom), B2 (middle) and B3 (top)

The cored cylinders are presented in wooden boxes, with the start of the coring at the right side in Fig. 20. No joint mortar is found in the cores, because the coring with water cooled diamond coring crown dilutes and erodes the joint material, and as a consequence only natural stone fragments remain. At coring the drill master observed soil fragments, which confirms that the foundation masonry at the bottom is only a loose stack of blocks, without mortar. Core B2 at the SW-corner of the church contained a coherent piece of cement concrete. This anomaly in the foundation of an historic foundation was the direct reason for

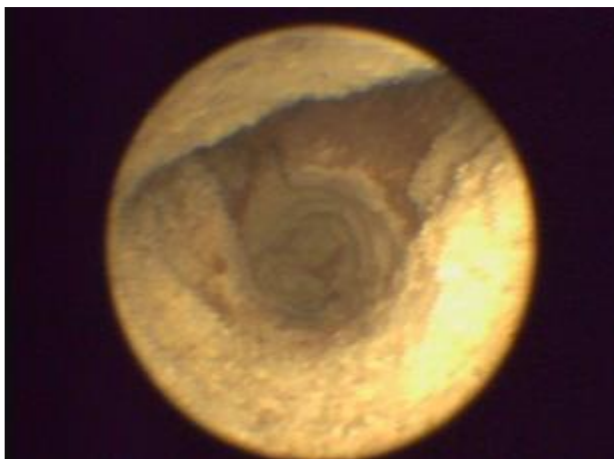
The foundation masonry of the NW baptistery chapel consists of natural stone masonry (upper 90 cm), followed by brick masonry. Smaller holes were detected in the natural stone masonry (incomplete filling of joints). A larger void was detected at the transition from natural stone to brickwork, Fig. 21.

Fig. 21 Endoscopy E4, NW chapel, depth 85 cm: holes at transition of natural stone to brick masonry

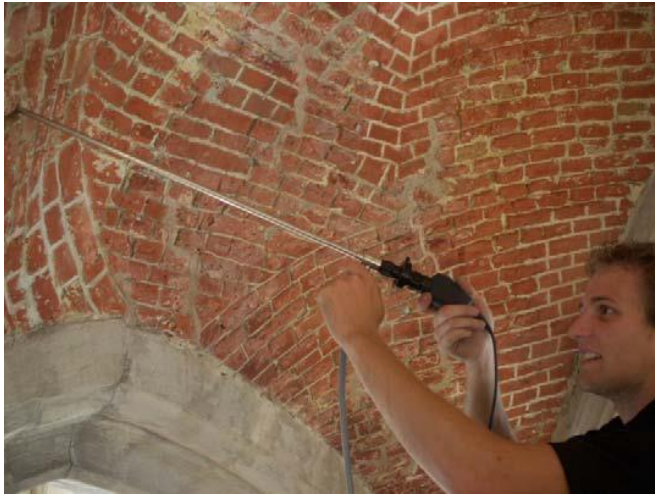
Fig. 31 Endoscopic examination

It was found that the vault thickness in the bulged zones was only 7 to 10 cm. In these lower parts the vault thickness is only half-brick, whereas it is full brick in the upper zones. At boring the hole, a dark and crumbly powder flows out of the hole. The borehole walls are very porous and incoherent. They consist of a light colored lime mortar and fragments of brick, stone and slate. The inside of the vault in the bulged zone is plastered at several places (thickness 2 to 3 cm), with painted brick pattern.

The brickwork of the vault in the bulged zones is heavily cracked and very soft. Combined with the loose backfill at the vault tips, this creates a dangerous and unstable situation, ultimately leading to brick fall. For that reason the bulges are consolidated with sock anchors, provided with a wider pinion at the vault inside to support the masonry. Sock anchors have a diameter of 10 to 12 mm, with at the center a reinforcing element with diameter 6 to 8 mm. Sock anchors can be placed in a borehole of 12 to 14 mm. Pinion and sock anchor are glued in the borehole with a mineral grout. The borehole at the inside of the vault is widened to allow a hidden placement of anchor and pinion.

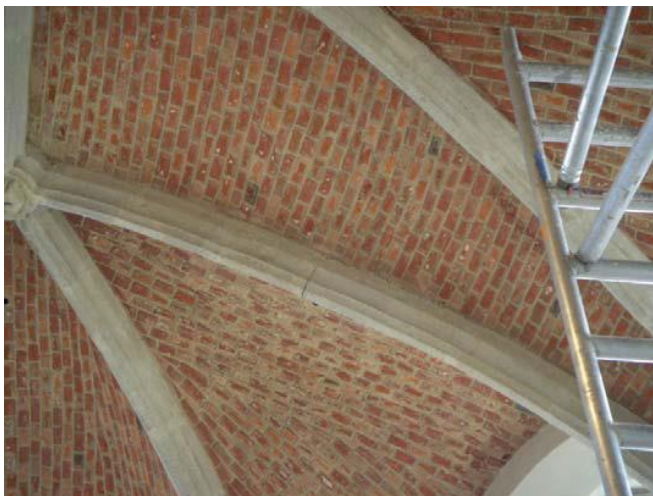
A detached rib was discovered in the choir after cleaning of the vaults. The detached rib is shown in Fig. 34.

Fig. 34 Detached vault rib

The detached ribs is joined with the masonry vault by means of sock anchors, Fig. 35. The sock anchors are bored in and grouted from above. In this way the rib forms a unity with the vault masonry, and the composite structure acts as vault supporting rib.

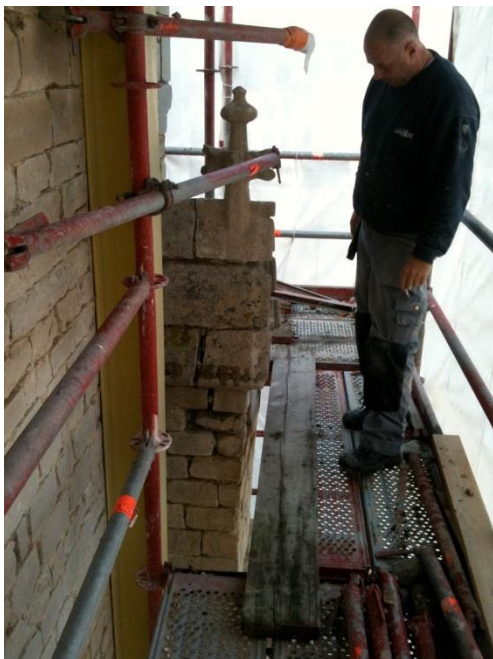
The stone masonry at the top of the transept buttresses is strongly eroded, Fig. 36. By ingress of rain water and by frost-thaw effects the coherence is disturbed: the parament blocks are lying on each other without mortar bond. Therefrom, demounting the parament stones was very simple, Fig. 37. A lot of plant roots were present at the transition between parament and core masonry.

Fig. 36 Degraded masonry at top of transept buttress

The degraded core masonry is removed till no vegetation roots could be found. After that, stainless steel anchoring rods (\varnothing 16 mm, length 600 mm) were bored in every 25 cm, and grouted with ternary grout. The anchoring depth in the core masonry is 300 mm, whereas the remaining 300 mm is embedded in the new, substituting core masonry composed of massive bricks, placed with a lime-cement mortar: 1 volume part of hydrated lime, 1 part of cement, 5 parts of sand (in weight parts: 6 kg hydrated lime, 10 kg cement, 80 kg sand). After replacing a row of parament stones, the vertical joint between the core and the parament is filled with ternary grout, to ensure a perfect contact and bond between both. The original parament blocks could be reused for the reconstruction of the transept buttresses.

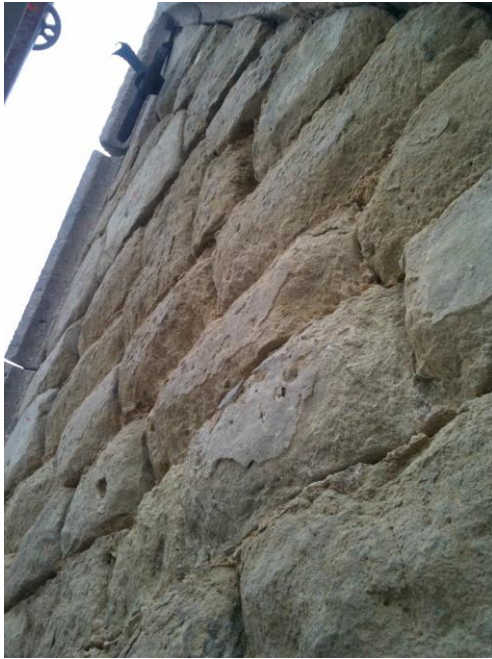
The parament masonry of the northern wimpergs is strongly degraded, Fig. 38. The southern wimpergs are in better condition, because they already have been renovated at an earlier restoration phase around 1900, in which these southern wimpergs were renewed with Euville natural stone.

Fig. 38 Strong exfoliation of Ledian natural stone at the northern wimpergs

Because of this strong degradation it was decided to demount the three northern wimpergs piece by piece and stone by stone, and to replace them in the same configuration. Heavily degraded blocks were recut when possible. Missing blocks were replaced by new stones of Massangis roche jaune. The replaced parament is anchored in the backing masonry by means of grouted anchors. For each row of parament stones, anchors are grouted with ternary grout in the masonry behind, and the vertical joint was first filled with mortar as good as possible. After that the vertical joint was further filled with ternary grout to obtain a complete filling of all voids between mortar and masonry, as well as to obtain a partial consolidation of the backing masonry. This procedure is repeated at each row of replaced parament stones. The consistency of the grout allows its use for about two hours. Therefore, grouting did not hinder at all the block laying activity. The execution is shown in Figures 39 and 40.
